# THE SIXTY-STOUREY CRISIS

THE STORY BEHIND BC HYDRO'S WORST NIGHTMARE: THE DISCOVERY OF A HOLE IN ITS MASSIVE BENNETT DAM AND THE BEHIND-THE-SCENES EFFORTS TO ENSURE THE UNTHINKABLE – A BREACH IN THE DAM – WOULD NEVER HAPPEN

by Anne Mullens

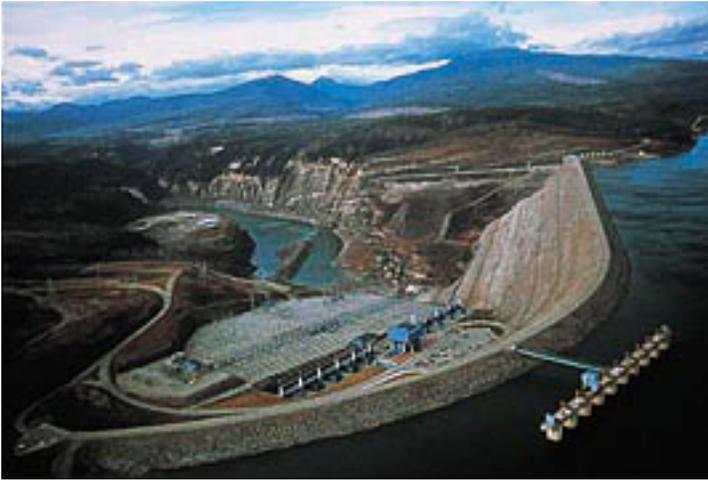
The WAC Bennett Dam holds back the largest reservoir in North America.

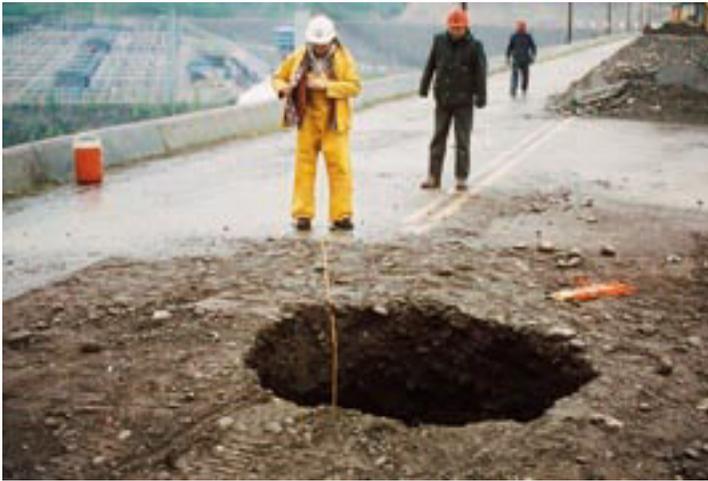
At the sinkhole, prompt action prevented any chance of a dam breach that would have unleashed a wall of water on downstream communities.
